No Gap in Performance

After a 21-year span, the original coating on Windgap Bridge still looks like new.

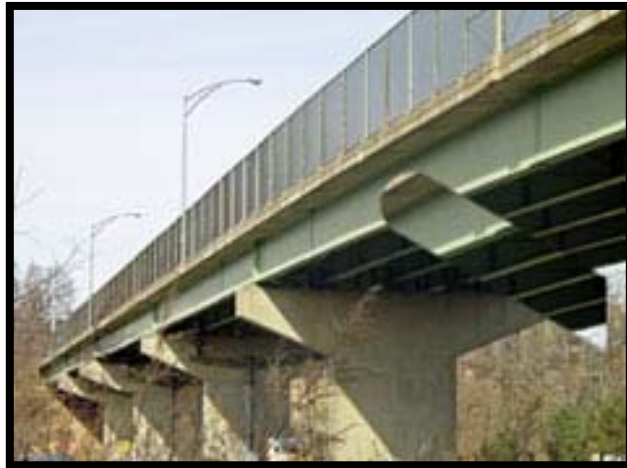
For more than 21 years, the Windgap Bridge has stood up to rugged use.

In April 2007, 16 years after the last inspection, KTA-Tator conducted another inspection and confirmed that the coating system was still in excellent condition. Their report states, "The overall rate of rusting and the coating breakdown (0.03% or less of the painted surface area) is considered to be low, especially for a structure that is subject to the Pennsylvania winter freeze/thaw cycling and the frequent application of corrosive de-icing salts." KTA-Tator's report further noted that although leakage in the expansion joints of the concrete on the bridge deck caused minor corrosion to the adjoining painted steel, these were the only areas of corrosion on the bridge.
