## Those Cracks on the Edge of the Road ...What Causes Them?

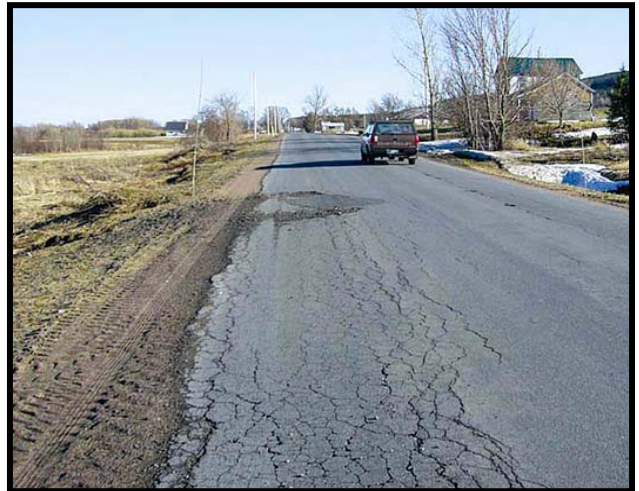
The first photo illustrates the sort of cracks I'm referring to, and it gives us our first clues. The cracking here is fairly extensive, covering the entire outer wheelpath. The curved nature of the cracks is not so easy to see here because transverse cracks have formed between the parallel arcs.

**Clue #1** – Note the very dirty material on the shoulder. It will not let the water get out of the base beneath the pavement edge after it enters through the cracks. This softens the subgrade and base under the edge of the pavement.

**Clue #2** – Note the shallow rut in the inner wheelpath. This suggests that the surface and base are weak (i.e., too thin).

**Clue #3** – Note also that the road is not very wide. The vehicle that is traveling away from us in the photo would need to shift closer to the edge of pavement to pass a vehicle coming in the opposite direction. This can pose a safety hazard.

If the damage is as extensive as in the first photo, the best solution may be to remove and replace the surface *and* the base. Remove the cracked section, then provide a new gravel base that is clean and will drain well, improve the shoulder drainage, and put back the pavement thickness that will support the traffic. We realize that in most cases such extensive reconstruction simply will not be done. But the three remedial measures listed above will re-establish the pavement edge, which will make the road safer and smoother to drive on for a period of time.

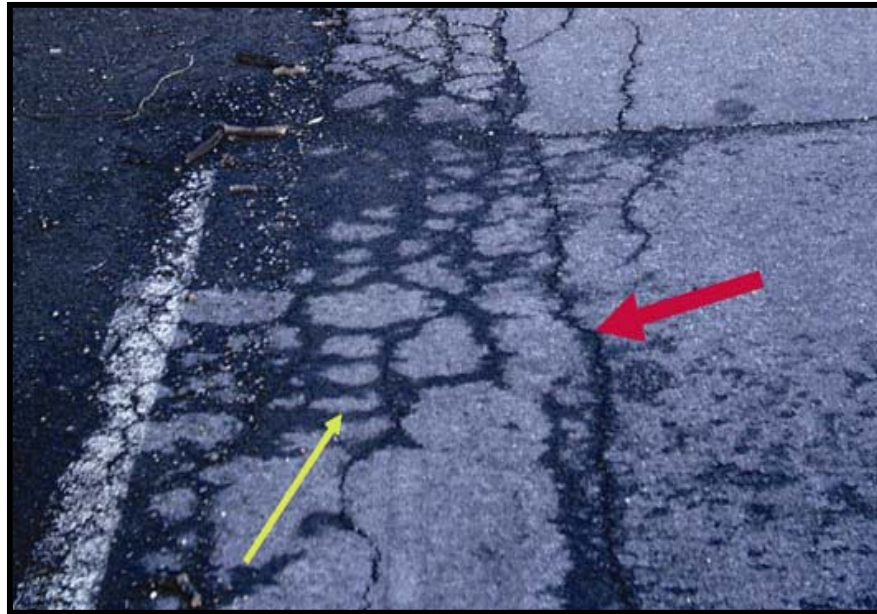
- ❖ The surface and base are both relatively thin, and hence not very strong.
- ❖ The shoulder material and probably also the base are dirty, which makes them "frost susceptible." Such materials tend to grow ice lenses and heave during the winter, and they become very weak and unstable during spring thaw.

- ❖ The base under the asphalt thaws before the subgrade. The excess water cannot drain out in the early spring until the shoulder is completely thawed.

- ❖ Drainage away from the edge of the road is poor. Water is held near the pavement edge and it weakens the dirty base and shoulder materials.
- ❖ In some cases "box construction" may be involved. This means a trench was cut and the road was placed in it. Eventually water gets under the road, but the base is in a "box" so the water cannot drain out.

- ❖ Narrow lanes force the traffic to get very close to the edge of the pavement. Traffic only does this when there is a passing vehicle; otherwise vehicles align themselves closer to the middle of the road. Trucks, being wider, tend to travel near the edge of the lane more often, putting the heaviest loads on the edge of the pavement. **This is a major factor causing the problem.**

- ❖ The wheel loads near the edge of the road bend the pavement down, especially when the base and shoulder materials are weak, as during spring thaw. This causes a tension crack to form, and it widens and propagates with repeated loading.

- ❖ As the crack gets longer it eventually turns toward the outer edge of the pavement, making the characteristic "C" shape. It doesn't turn inward because the pavement is more resistant to cracking in that direction. It doesn't run parallel to the pavement edge because at some point the support gets stronger, and so the crack turns outward.

- ❖ The edge cracks allow surface water to filter into the base and weaken it more. More cracks lead to more water and a softer base and subgrade.

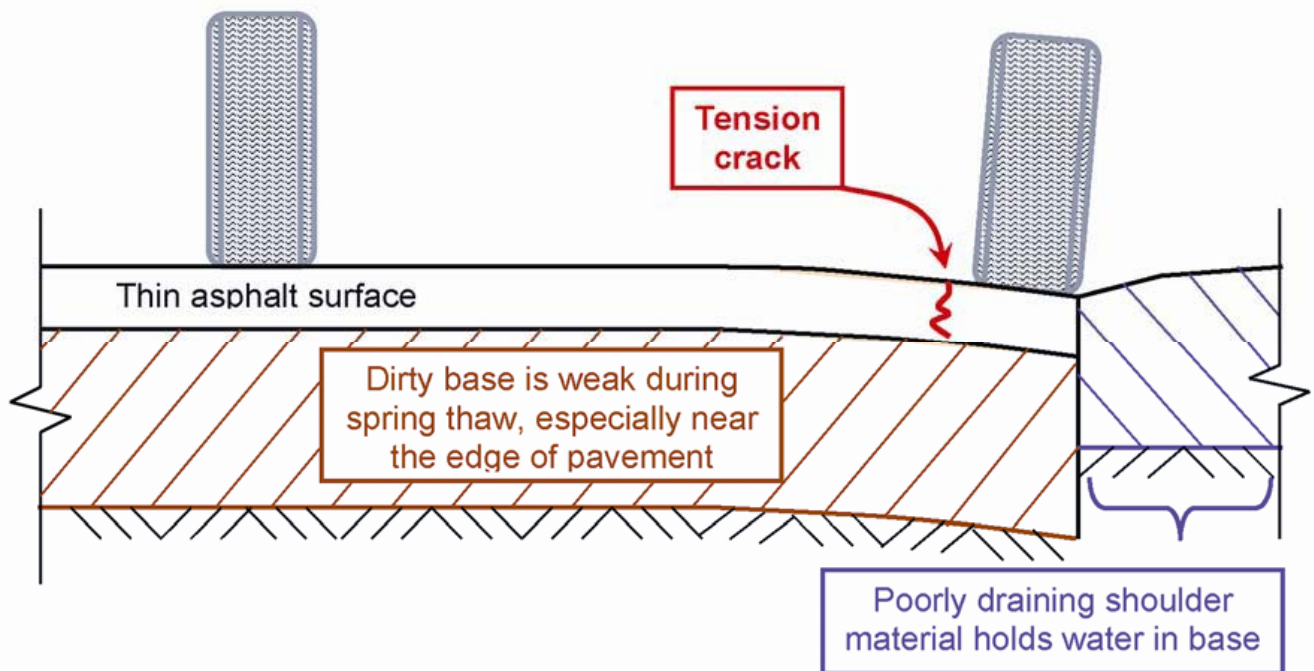
The drawing below illustrates these points. The edge deflection under the wheel is greatly exaggerated.

1. Promote good drainage along the edge of the road. Make sure that surface water will run to the nearby ditch, and not pond along the pavement edge.
2. Remove the dirty, poor draining shoulder material and replace it with a more permeable material. "Daylight" the material to the ditch so water in the base can get out.
3. If you have a lot of truck traffic, place a substantial structural overlay on the road surface. You need three or four inches of hotmix to provide adequate support for today's heavier vehicle loads.

It would also help to widen the road if you have enough right-of-way to permit doing that. Eleven or twelve foot lanes are commonly used these days for traffic safety. We think of wider lanes being done for this reason only. However, there is also some added benefit in helping the longevity of the pavement by getting the heavy loads away from the edge of the road.
